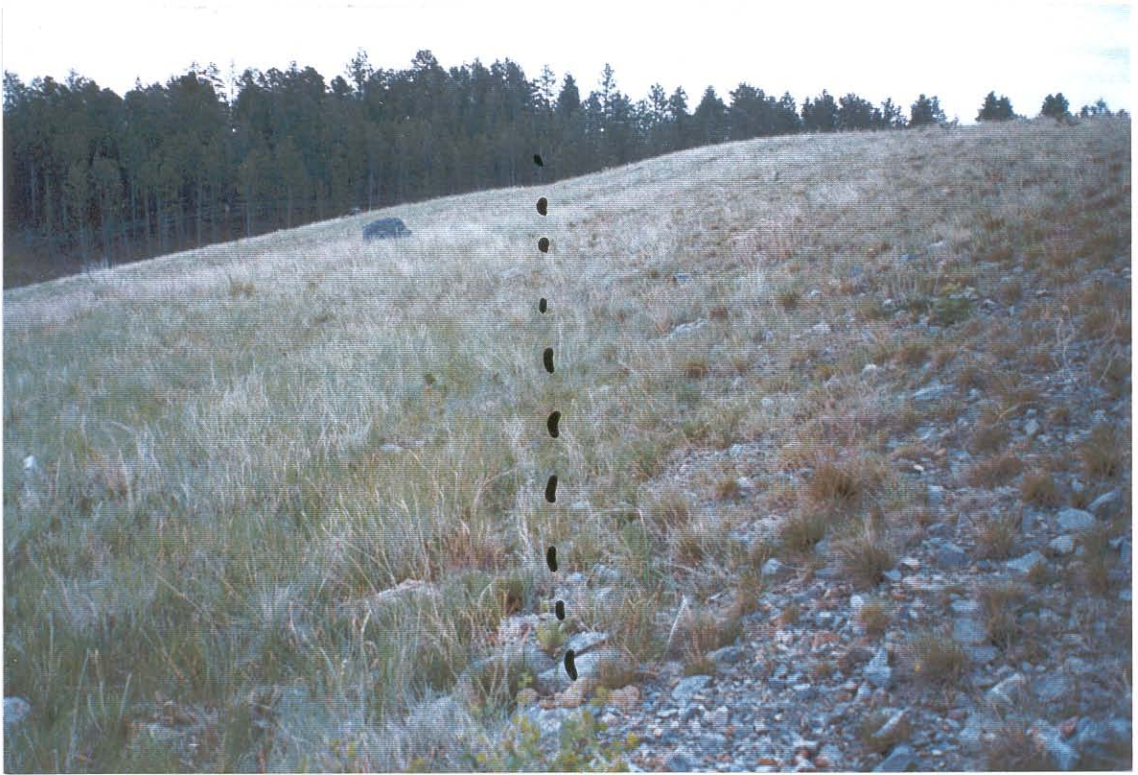
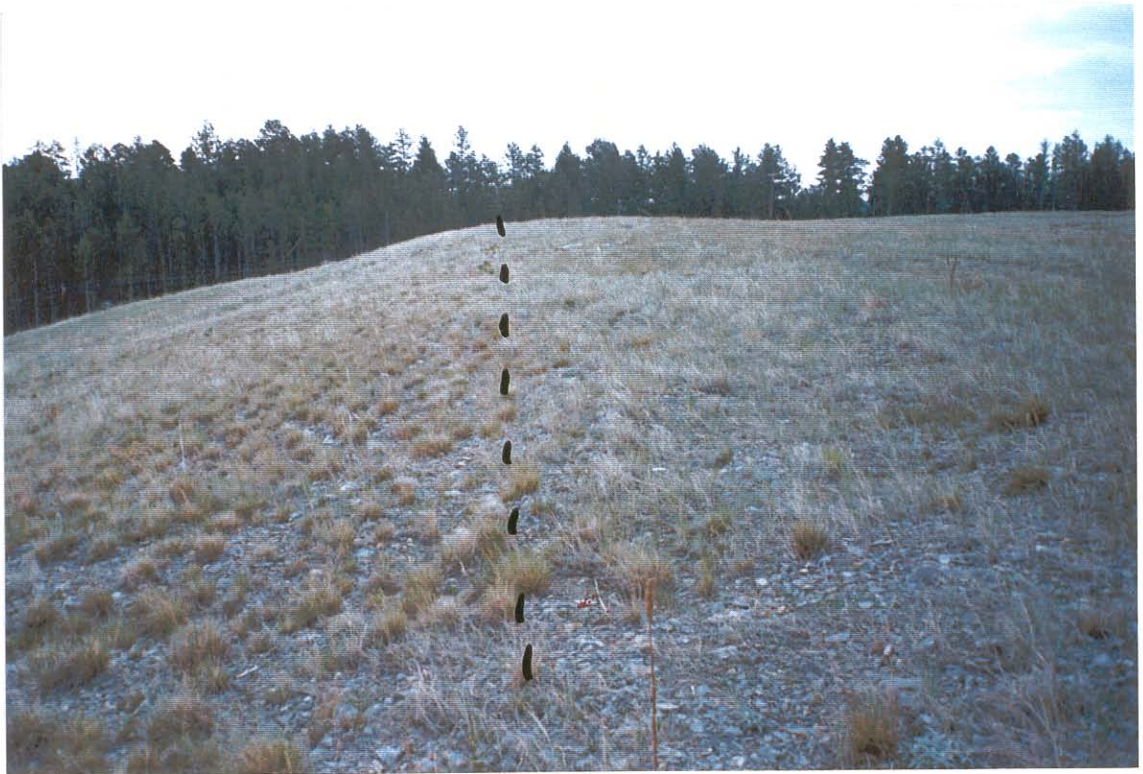
Figure 6. The Muleshoe Dump consists of several different covers. The WNW aspect indicated in the left portion of the upper photo has a good coversoil (shown in Figure 7) giving way to a thinner, rocky coversoil/sheep fescue community toward the spur ridge (Figure 8). The lower photo shows the effect of the aspect shift to the southwest.

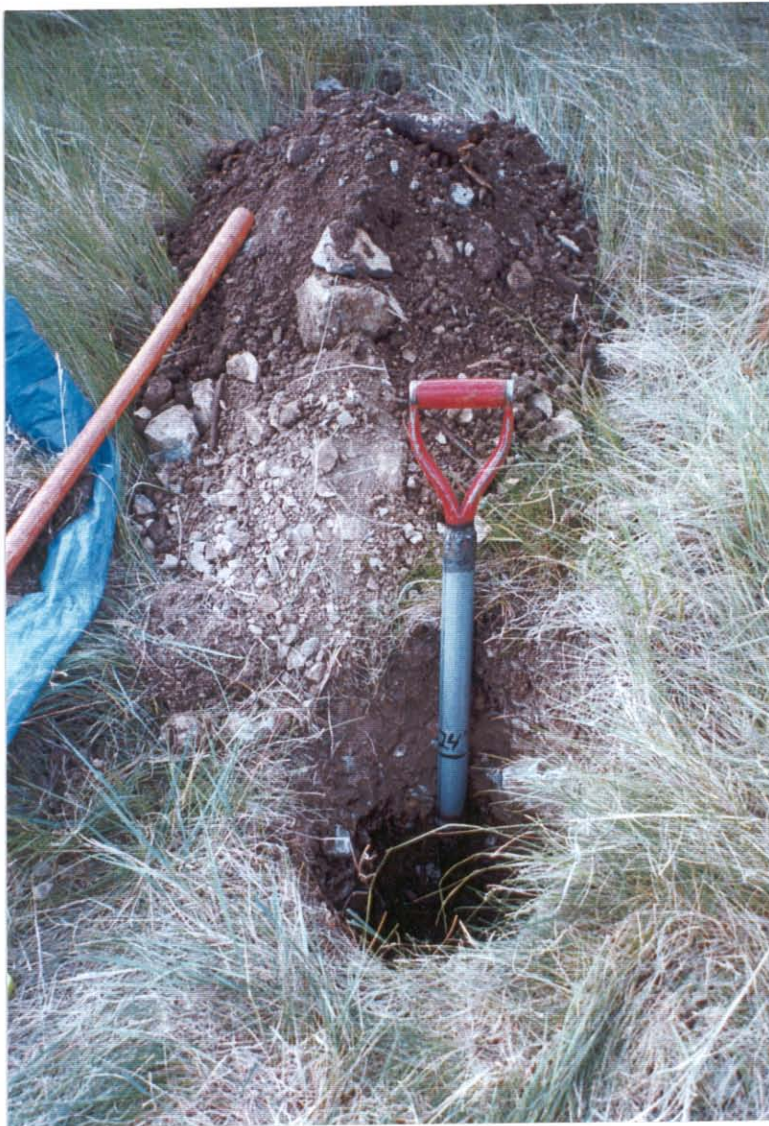
Figure 7. A good-looking 29"-thick coversoil is associated with the luxuriant vegetation in Figure 8. The coversoil has a moderate amount of coarse fragments and also contains some wood pieces. More plant-available P would benefit plants.

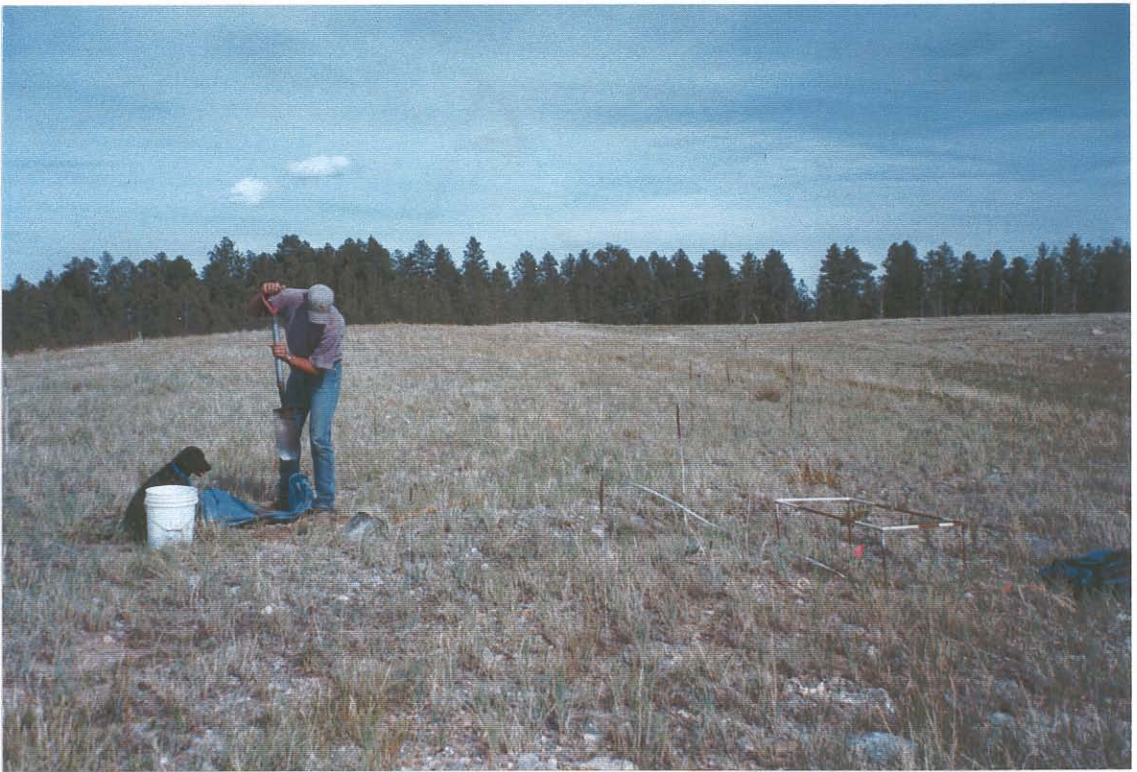
Figure 8. In contrast, this 17"-thick, rocky coversoil -- combined with a warmer aspect -- typifies another portion of Muleshoe Dump revegetation. Warm-aspect, upland revegetation is always the most difficult to revegetate satisfactorily. A high rock content is unnecessary on gentle slopes. This site is supporting about all the photosynthesis it can. The "?" refers to the questionable designation as soil.

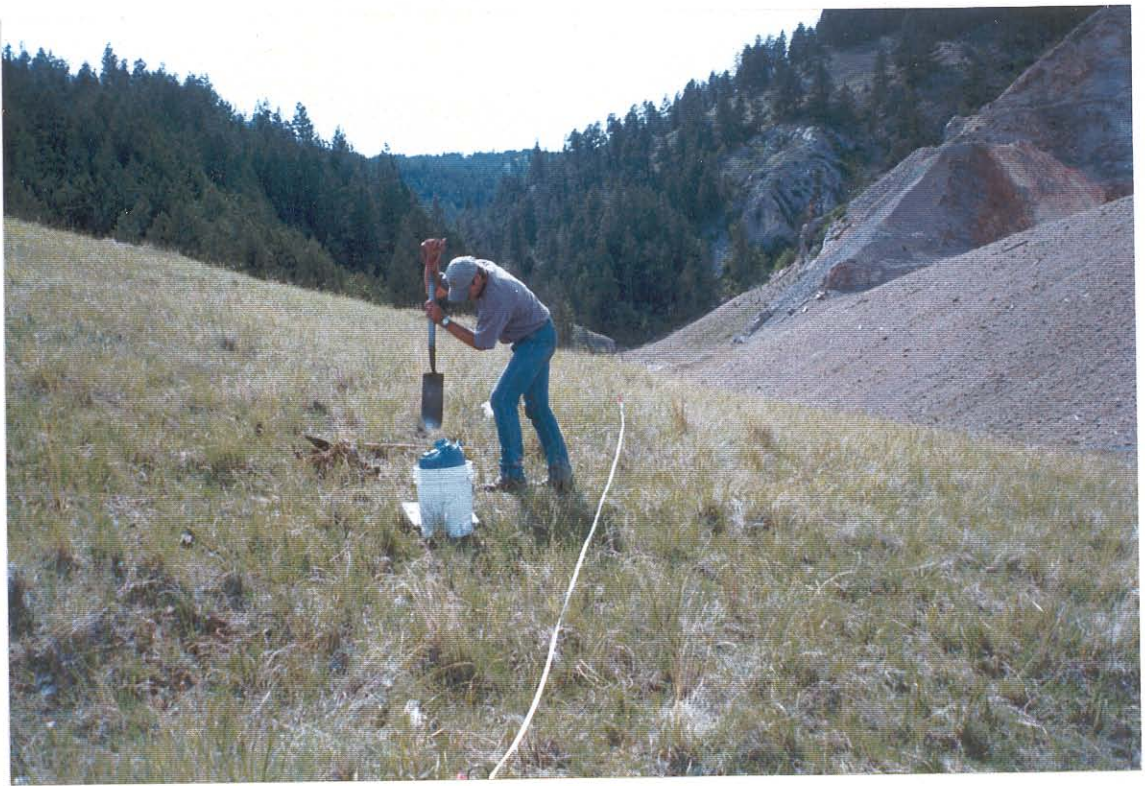
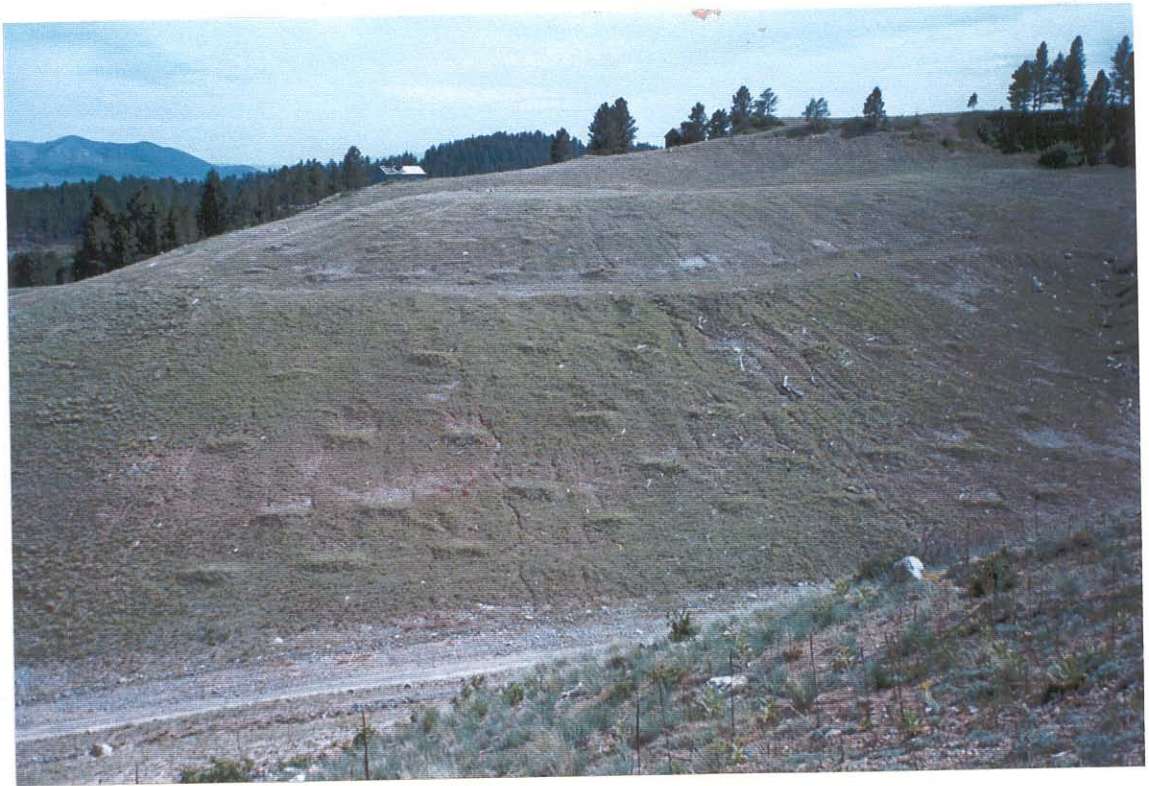
Figure 9. Another manifestation of aspect + coversoil can be found at the Horseshoe Dump. The north face, shown here, looks pretty good although dozer basins were not properly placed to assure that overflow from one basin would flow into the next downhill basin. It's a quality coversoil 17" thick with minimal coarse fragments and lower bulk density than other sites. (Bulk density wasn't quantified, but digging soils pits gives you a pretty good index.)

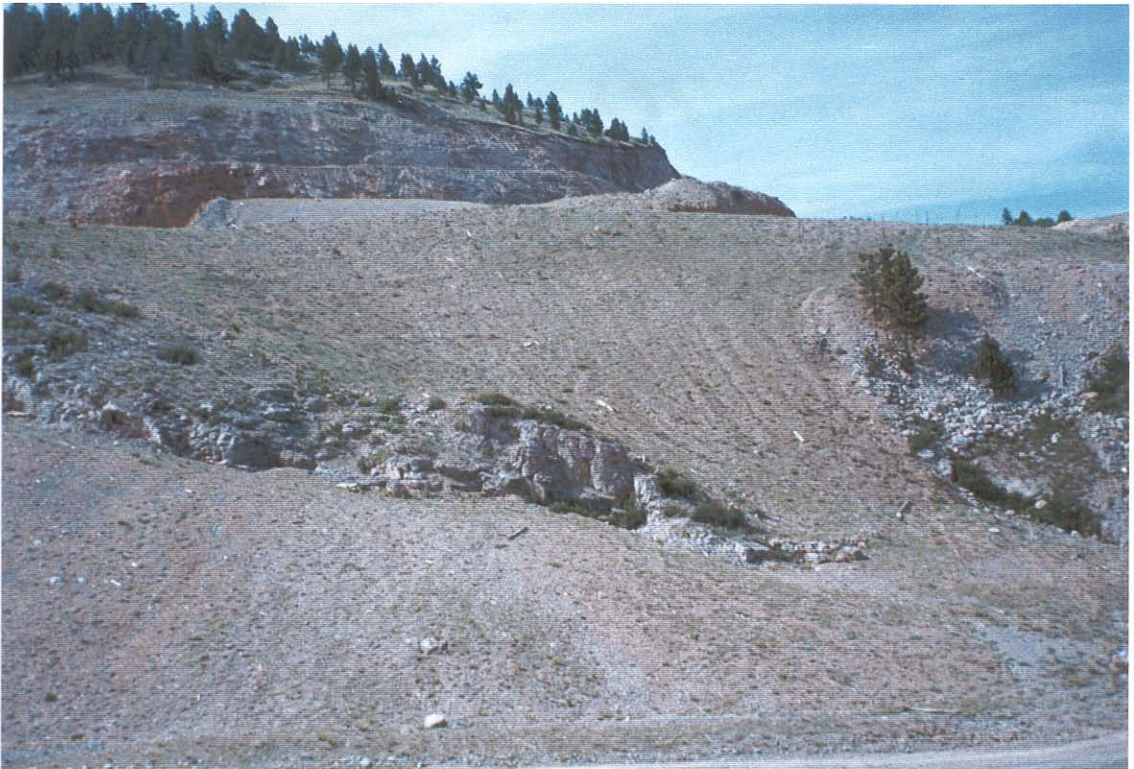
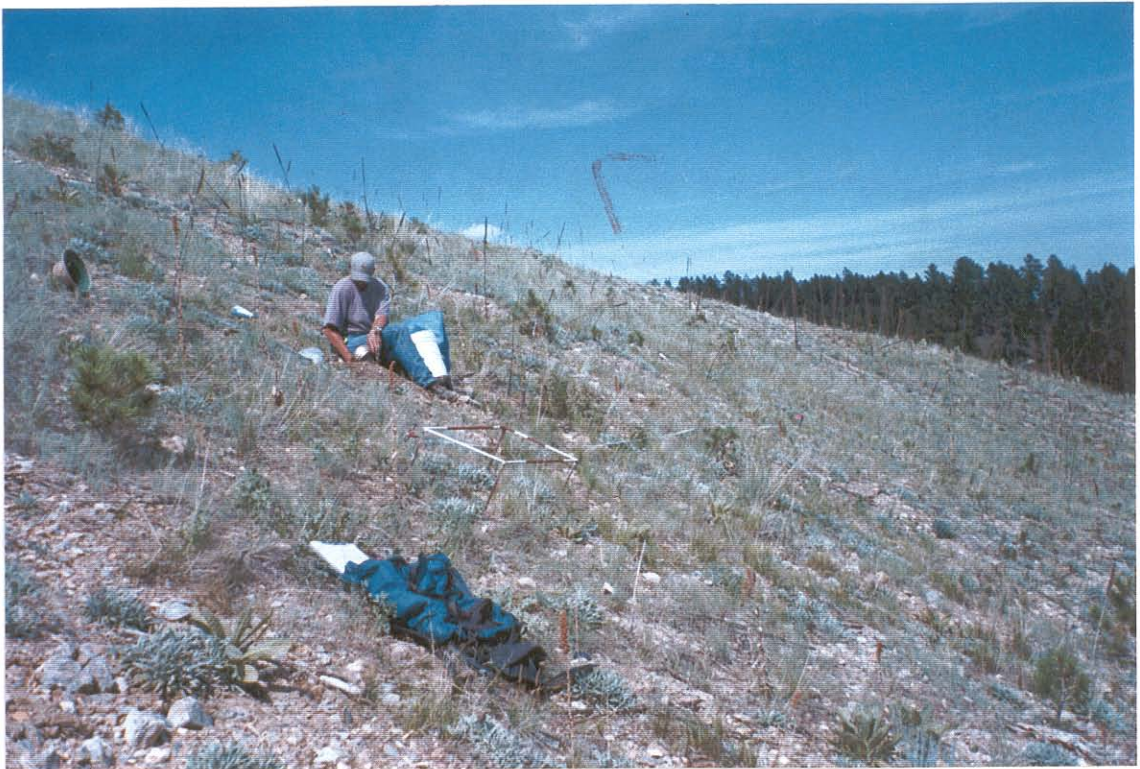
Figure 10. The south-facing aspect of Horseshoe Dump reclamation is a lot more like primary succession than is the north face. The rocky coversoil is about 15" thick. The slope is pretty well armored with rock but won't support a lot of grasses, but it's a decent site for woody plants.

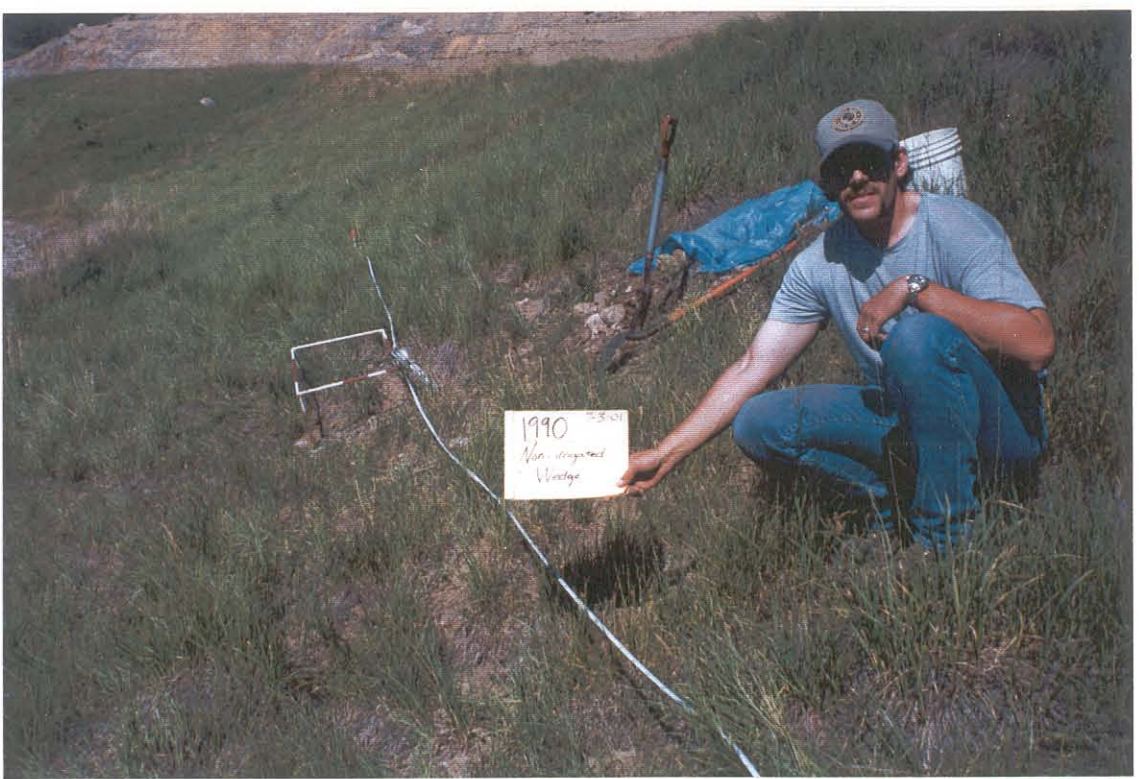
Figure 11. This wedge of 1990 revegetation between upper and lower roads is generally well vegetated, with some localized erosion (not shown). The difference is shallower coversoil (10" vs. 15") and more coarse fragments, including large cobbles, in the eroded area. Rocky coversoil control erosion, but to the extent that they limit plant abundance, they assure some erosion.
